**Flood Control Project Maintenance
Levee Inspections**
LMA District Cover Sheet
Spring 2018 Levee Inspection Results

Reclamation District No. 1500 Sutter Basin

Spring 2018 Levee Inspection Results

Waterway			Bank	Unit Miles
Unit No. 01 Sacramento River			Left	33.15
	Spring (March - May)	Summer (June - August)	(September - November) Fall	Winter (December - February)
Unit Maintenance Rating (Fall Only)				
Date of Inspection	3/27/2018 - 3/28/2018			
DWR Inspector	Zach Jojola			
Accompanied By	Hiromi Tomita RD 1500

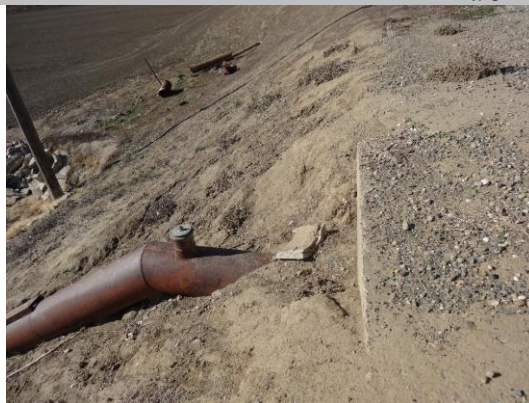
Photo 3 of 3 : UCIP_SP_2018_28505_52515.jpg

LS view: siphon breaker (left) on exposed steel pipe on levee slope.
Concrete pad (right) on levee shoulder.

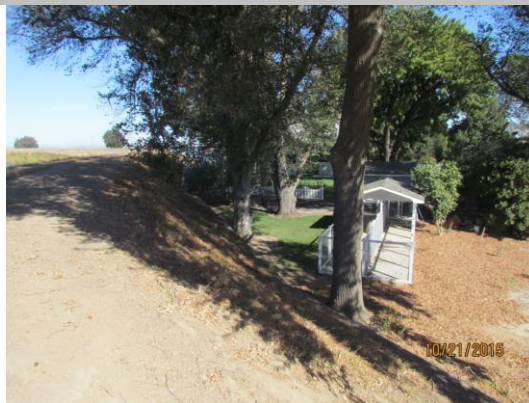
Photo 1 of 1 : SP_2018_RD1500_189_36_20180306_00029.jpg

LM Start	18.98	Rating **	M	Issue No.	36
LM End	18.98	Issue Type +	En	Location *	LS
Category	Earthen Levee			GPS Latitude/Longitude	
				Start	End
Item	Encroachments			38.901570 °	38.901570 °
				-121.791235 °	-121.791235 °
DWR ID	DWR_RD1500_01_s_2012_36				
Comment Code					
BU : Building					
Inspector Comment					
Concrete retaining wall toe of landside levee. Permit #10065

View of the building on the landward side of the levee looking upstream.
Fall 2015.

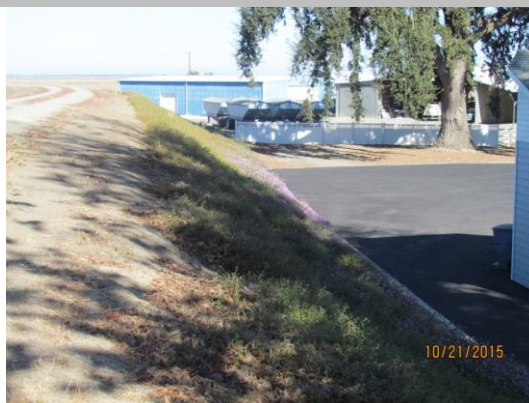
Photo 2 of 2 : SP_2018_RD1500_189_37_20180306_00031.jpg

View of the groundcover on the landward side of the levee looking upstream. Fall 2015.

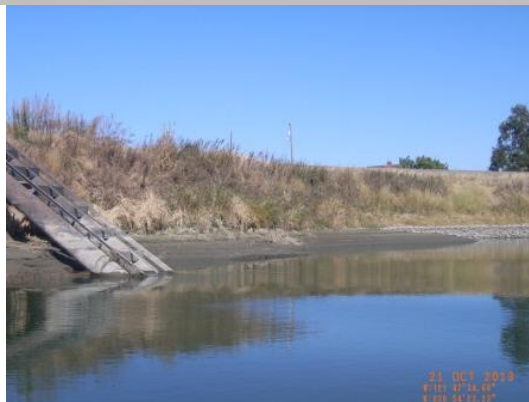
Photo 1 of 1 : SP_2018_RD1500_189_5_20180306_00005.jpg

LM Start	19.16	Rating **	A/W	Issue No.	5
LM End	19.47	Issue Type +	Ma	Location *	WS
Category	Supplemental			GPS Latitude/Longitude	
				Start	End
Item	2015 USACE Erosion Survey, DRAFT			38.904041 °	38.906697 °
				-121.790298 °	-121.792796 °
DWR ID	DWR_RD1500_01_s_2016_5				
Comment Code					
Inspector Comment					
1997 - Cobbles eroded off the clay materials; not much evidence of erosion on the toe; cobble loss on the toe. 2011 - Some minor new erosion. 2015: No observed changes. [2015 Site ID: SAC_104-5_L]

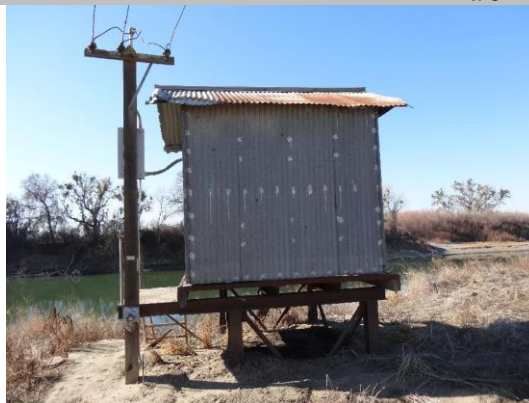
Photo 1 of 3 : UCIP_SP_2018_28506_52523.jpg

Comment Code						
Inspector Comment						
FS_ID:28506 DS_ID:20087 EP_NO: 550 Repair Type: Non-Urgent Crossing Status: Found UCIP Comments: Surface erosion on landside slope.Oil leaks from the pump. FIELD_STRUCT_DESC: 14-inch coated steel irrigation discharge pipe through the levee, 4.8 feet below the crown. Two concrete cutoff walls. Slant pump and gate valve in a corrugated metal pump house on a steel structure on the berm. Water meter installed on the pipe on the waterside (WS) slope. Screw gate at the landside (LS) end. Concrete distribution box on the LS. (Installation of a pump and a 14-inch steel discharge pipe through the levee authorized under Permit No. 550, 1931 - P. J. Hiatt. Replacement of a failing 14-inch pipe with the same size pipe through the levee authorized under Permit No. 17648, 2003 - Van Ruiten Brothers). [Additional Reference(s): DWR Levee Log, 1993. USACE Sacramento O&M Manual 128, March 1960, (HLM 19.44)]. FS Date: 1/14/2014

WS view: slant pump in CM shed on levee berm. Oil leaks from the pump.

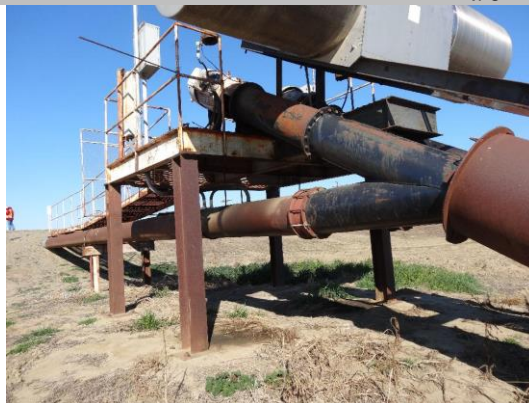
Photo 1 of 3 : UCIP_SP_2018_28524_52551.jpg

Comment Code						
Inspector Comment						
FS_ID:28524 DS_ID:20004 EP_NO: 15681 Repair Type: Non-Urgent Crossing Status: Found UCIP Comments: Obstructed siphon breakers on landside.Two 3-inch conduit through the levee.Service box on pump platform.Pumping plant was working during the field visit. FIELD_STRUCT_DESC: 1 of 2: 16-inch steel irrigation discharge pipe, asphalt coated inside and out and wrapped with asphalt saturated felt, through the levee, 1.5 feet below the crown. Cutoff wall at the centerline of the levee. Two slant pumps supported by a steel piling structure on the riverbank. Steel walkway to the pump platform. Siphon breakers in steel pipe risers on the landside (LS) shoulder. Pipe discharges into a concrete discharge box off the LS toe. (Installation of a discharge pipe through the levee and a slant pump on the riverbank authorized under Permit No. 15681, 1991 - Blackfraires Investment). FS Date: 1/14/2014

WS view: pipe, walkway, slant pump, and steel platform on levee berm.

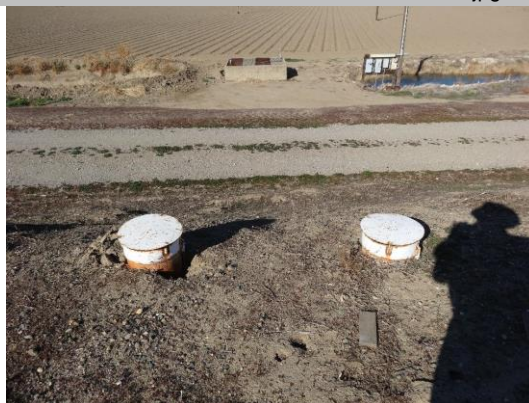
Photo 2 of 3 : UCIP_SP_2018_28524_52550.jpg

LS view: siphon breakers in steel pipe risers (bottom) on levee slope and concrete distribution (top) box on levee toe.

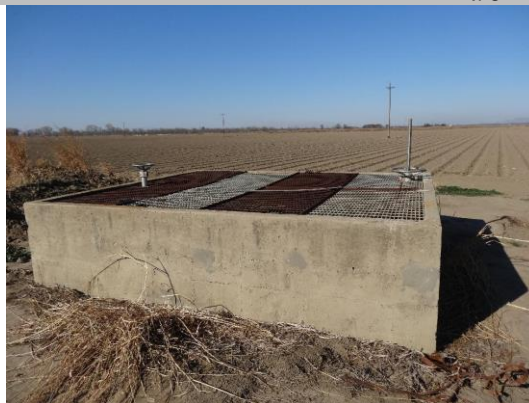
Photo 3 of 3 : UCIP_SP_2018_28524_52549.jpg

LS view: concrete distribution box on levee toe.

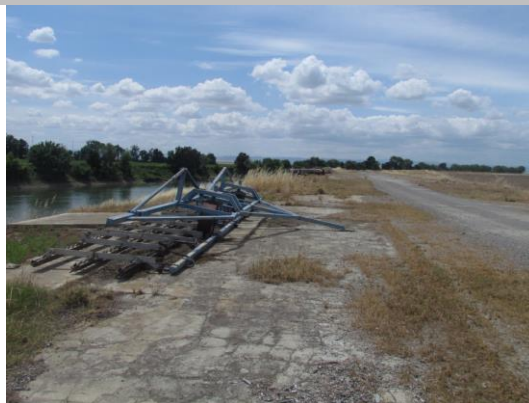
Photo 1 of 1 : SP_2018_RD1500_189_2549_20180306_00088.jpg

LM Start	19.56	Rating **	M	Issue No.	2549
LM End	19.56	Issue Type +	En	Location *	WS
Category	Earthen Levee			GPS Latitude/Longitude	
				Start	End
Item	Encroachments			38.906565 °	38.906565 °
				-121.794472 °	-121.794472 °
DWR ID	DWR_RD1500_01_s_2015_2549				
Comment Code					
EQ : Equipment					
Inspector Comment

View of the equipment on the waterward side of the levee looking upstream. Spring 2015.

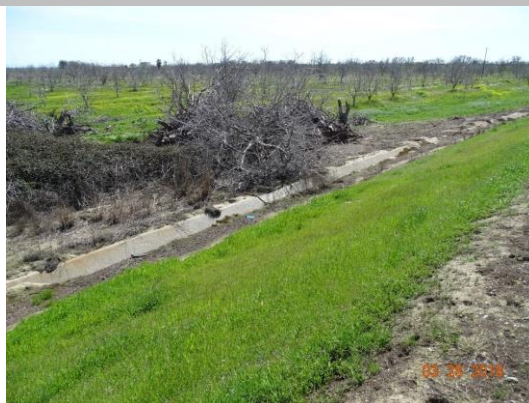
Photo 1 of 1 : SP_2018_RD1500_189_123_20180329_00238.jpg

LM Start	20.97	Rating **	M	Issue No.	123
LM End	21.15	Issue Type +	En	Location *	LS
Category	Earthen Levee			GPS Latitude/Longitude	
				Start	End
Item	Encroachments			38.910885 °	38.913199 °
				-121.804603 °	-121.803256 °
DWR ID	DWR_RD1500_01_s_2018_123				
Comment Code					
DT : Ditch					
Inspector Comment

View of ditch at the landside toe. Spring 2018.

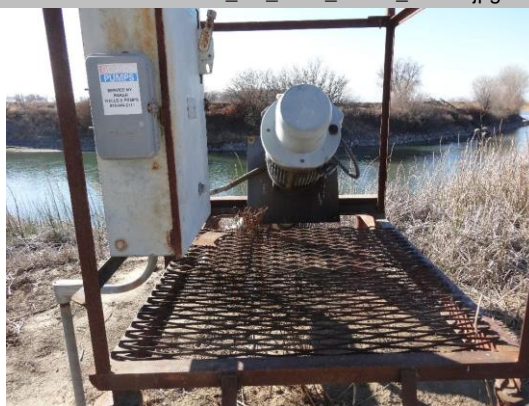
Photo 1 of 3 : UCIP_SP_2018_28527_52568.jpg

Comment Code					
Inspector Comment					
FS_ID:28527 DS_ID:20070 EP_NO: 11959A Repair Type: Non-Urgent Crossing Status: Found UCIP Comments: Siphon breaker (obstructed) in CMP on landside slope.Power pole on landside toe. FIELD_STRUCT_DESC: 10-inch coated and wrapped steel irrigation discharge pipe through the levee, 3 feet below the crown. Corrugated metal cutoff wall. Slant pump on a steel platform at the riverbank. Obstructed siphon breaker in a corrugated metal pipe (CMP) riser on the landside (LS) slope. Pipe discharges into a 6-foot by 6-foot concrete distribution box on the LS. (Replacement of an existing 10-inch steel pipe with a new 10-inch steel pipe through the levee authorized under Permit No. 11959-A, 1977 - George Van Ruiten Jr.). [Additional Reference(s): DWR Levee Log, 2005. USACE Sacramento O&M Manual 128, March 1960, (HLM 21.50)]. FS Date: 1/14/2014

WS view: slant pump on steel platform on levee berm.

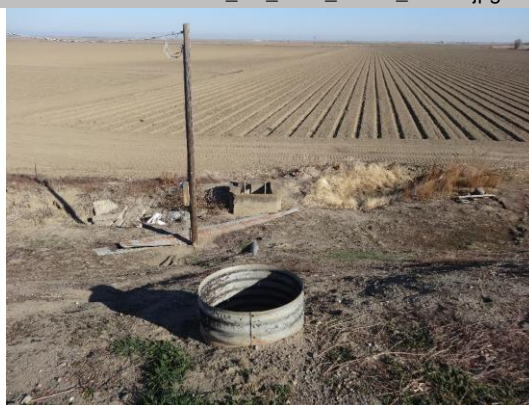
Photo 2 of 3 : UCIP_SP_2018_28527_52567.jpg

LS view: siphon breaker in CMP riser on levee slope (bottom) and concrete distribution box (top) on levee toe.

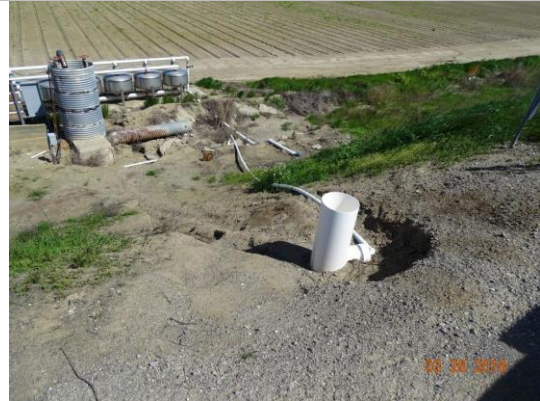
Photo 1 of 1 : SP_2018_RD1500_189_120_20180329_00236.jpg

LM Start	21.58	Rating **	M	Issue No.	120
LM End	21.58	Issue Type +	En	Location *	LS
Category	Earthen Levee			GPS Latitude/Longitude	
				Start	End
Item	Encroachments			38.916207 °	38.916207 °
				-121.808893 °	-121.808893 °
DWR ID	DWR_RD1500_01_s_2018_120				
Comment Code					
PI : Pipe					
Inspector Comment					
Erosion around PVC standpipe.

View of erosion around PVC standpipe. Spring 2018.

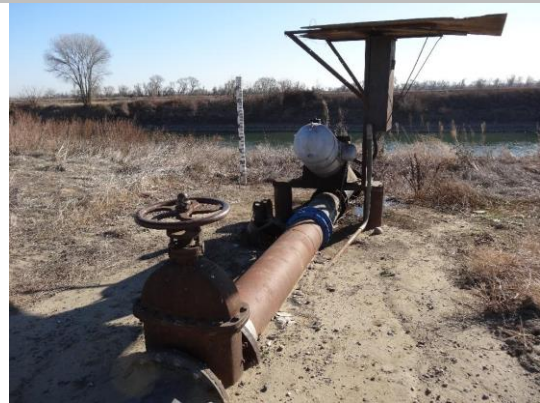
Photo 1 of 3 : UCIP_SP_2018_28528_52576.jpg

Comment Code					
Inspector Comment					
FS_ID:28528 DS_ID:20071 EP_NO: 10063 Repair Type: Non-Urgent Crossing Status: Found UCIP Comments: Water leaks near pump. Obstructed siphon breaker in CMP on landside.Plant was working during field visit. FIELD_STRUCT_DESC: 16-inch steel irrigation discharge pipe through the levee, 6.3 feet below the crown. Corrugated metal cutoff wall. 1.5-inch conduit through the levee, 6.5 feet below the crown. Slant pump and gate valve on riverbank. Siphon breaker in a 24-inch corrugated metal pipe (CMP) riser on the landside (LS) slope. 5-foot by 5-foot concrete distribution box on the LS. CMP standpipe on the LS toe. Power pole and one anchor at the LS toe. (Automatic Board Order (ABO) issued as Permit No. 10063, 1974 - Thomas L. Nelson). [Additional Reference(s): DWR Levee Log, 2005. USACE Sacramento O&M Manual 128, March 1960, (HLM 21.83)]. FS Date: 1/14/2014

WS view: slant pump on steel platform on levee berm. Exposed steel pipe with gate valve also on levee berm.

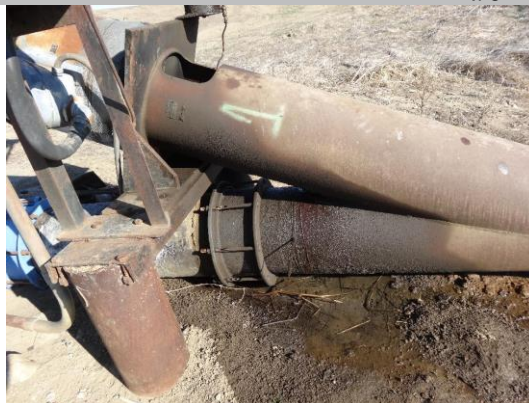
Photo 2 of 3 : UCIP_SP_2018_28528_52575.jpg

WS view: leaky inlet pipe near pump platform.

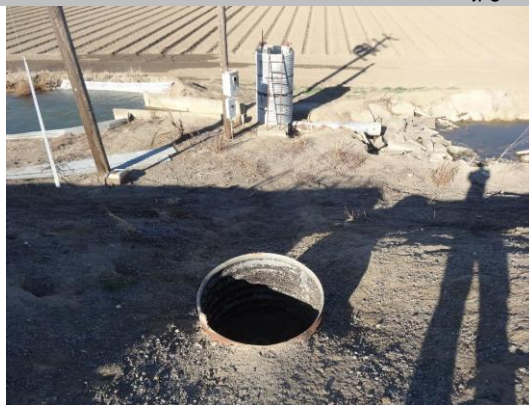
Photo 3 of 3 : UCIP_SP_2018_28528_52574.jpg

LS view: siphon breaker in CMP riser on levee slope (bottom) and CMP stand pipe (top) on levee toe.

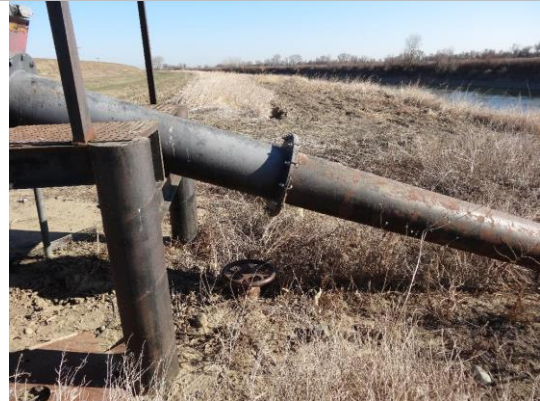
Photo 2 of 3 : UCIP_SP_2018_50192_52586.jpg

WS view: slant pipe and gate valve at the end of levee berm.

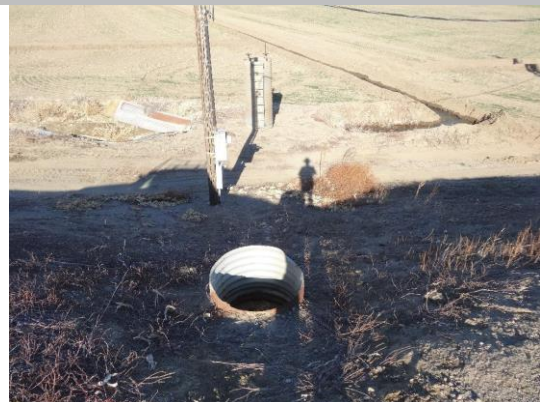
Photo 3 of 3 : UCIP_SP_2018_50192_52585.jpg

LS view: siphon breaker in CMP riser on levee slope (bottom) and CMP stand pipe (top) on the levee toe.

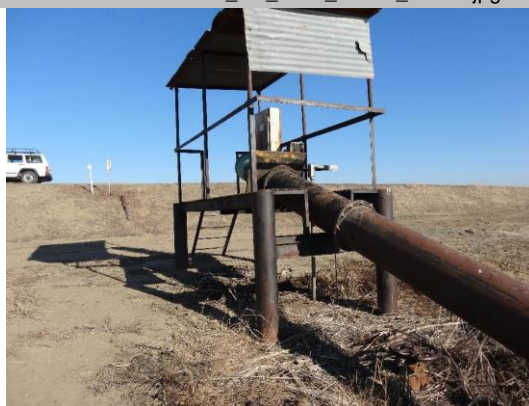
Photo 1 of 3 : UCIP_SP_2018_28583_52627.jpg

Comment Code					
Inspector Comment					
FS_ID:28583 DS_ID:19995 EP_NO: 10851 Repair Type: Non-Urgent Crossing Status: Found UCIP Comments: Exposed conduit on both slopes of the levee. Plant was working during field visit. Water was leaking from pipe joint near pump.Obstructed siphon breaker in CMP. FIELD_STRUCT_DESC: [Pumping Plant No. 2] 14-inch steel irrigation discharge pipe through the levee, 6.2 feet below the crown. Corrugated metal cutoff wall. 2-inch conduit through the levee, 5 feet below the crown. Pump and gate valve on a steel platform at the riverbank. Switch panel on the berm. Siphon breaker in a 24-inch corrugated metal pipe (CMP) riser on the landside (LS) shoulder. Pipe discharges into a 36-inch CMP standpipe at the LS toe. Meter pole at the LS toe. (Installation of three centrifugal pumps authorized under Permit No. 2895, 1958 - George Van Ruiten). [Additional Reference(s): DWR Levee Log, 1993. USACE Sacramento O&M Manual 128, March 1960, (HLM 23.00), 14-inch pipe referenced]. FS Date: 1/14/2014

WS view: slant pump on steel platform on levee berm.

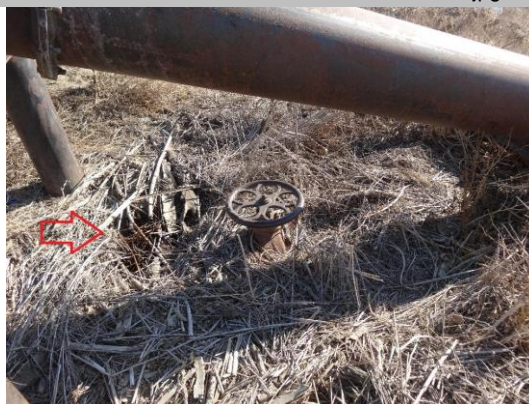
Photo 2 of 3 : UCIP_SP_2018_28583_52626.jpg

WS view: gate valve beneath slant pipe on levee berm. Water leaking from this pipe (marked).

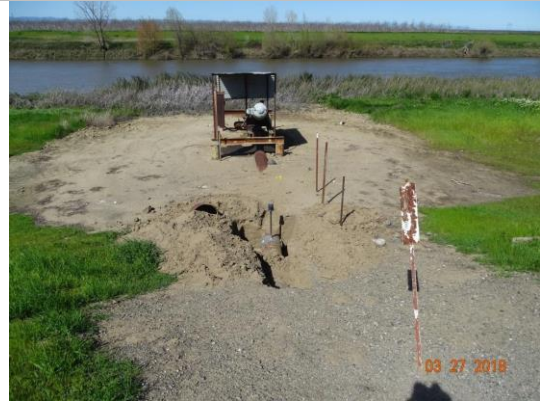
Photo 1 of 3 : UCIP_SP_2018_28586_77546.jpg

Comment Code						
Inspector Comment						
FS_ID:28586 DS_ID:20072 EP_NO: 2895 Repair Type: Non-Urgent Crossing Status: Found UCIP Comments: Most of the pipe exposed on levee slopes. Leaky pump. Obstructed siphon breaker. Not found- Concrete headwall at landward toe. FIELD_STRUCT_DESC: [Pumping Plant No. 1] 14-inch steel irrigation discharge pipe through the levee, 6.5 feet below the crown. Corrugated metal cutoff wall. 1.5-inch conduit through the levee, 4 feet below the crown. Slant pump and control panel on steel structure on the berm. Siphon breaker in a 24-inch corrugated metal pipe (CMP) riser on the landside (LS) shoulder. 36-inch concrete standpipe at the LS toe. Concrete headwall at the LS toe. Meter pole at the LS toe. (Installation of three centrifugal pumps authorized under Permit No. 2895, 1958 - George Van Ruiten). [Additional Reference(s): DWR Levee Log, 2005. USACE Sacramento O&M Manual 128, March 1960, (HLM 23.92), 24-inch pipe referenced]. FS Date: 1/14/2014

WS view: Currently installing a new meter. Still needs backfill. Levee inspector: Zachary Jojola.

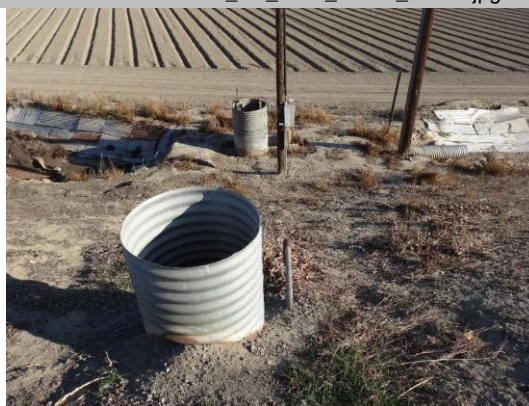
Photo 3 of 3 : UCIP_SP_2018_28586_52641.jpg

LS view: siphon breaker in CMP riser on levee slope (bottom) and CM standpipe (top) on levee toe.

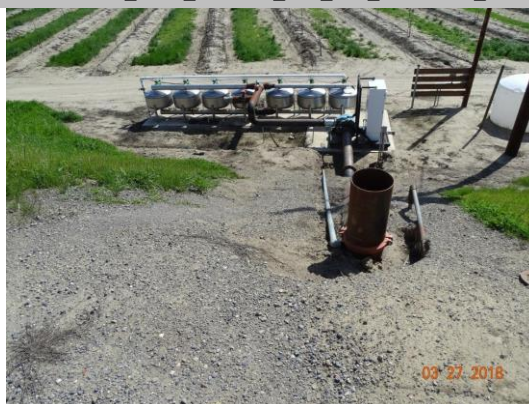
Photo 1 of 1 : SP_2018_RD1500_189_112_20180329_00235.jpg

LM Start	23.66	Rating **	M	Issue No.	112
LM End	23.66	Issue Type +	En	Location *	LS
Category	Earthen Levee			GPS Latitude/Longitude	
				Start	End
Item	Encroachments			38.930280 °	38.930280 °
				-121.834957 °	-121.834957 °
DWR ID	DWR_RD1500_01_s_2018_112				
Comment Code					
PI : Pipe					
Inspector Comment					
Runoff around landowner's corrugated standpipe. Recommend filling eroded areas and monitoring.

View of erosion around standpipe on the landside slope. Spring 2018.

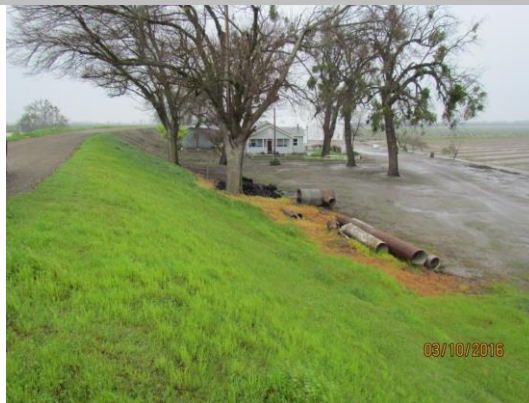
Photo 1 of 1 : SP_2018_RD1500_189_176_20180306_00081.jpg

LM Start	23.71	Rating **	M	Issue No.	176
LM End	23.71	Issue Type +	En	Location *	LS
Category	Earthen Levee			GPS Latitude/Longitude	
				Start	End
Item	Encroachments			38.931045 °	38.931045 °
				-121.834795 °	-121.834795 °
DWR ID	DWR_RD1500_01_s_2016_176				
Comment Code					
EQ : Equipment					
Inspector Comment					
New corrugated standpipe installed. Beginning to erode. Recommend monitoring.

View of the pipes along the toe of the landward side of the levee looking upstream. Spring 2016.

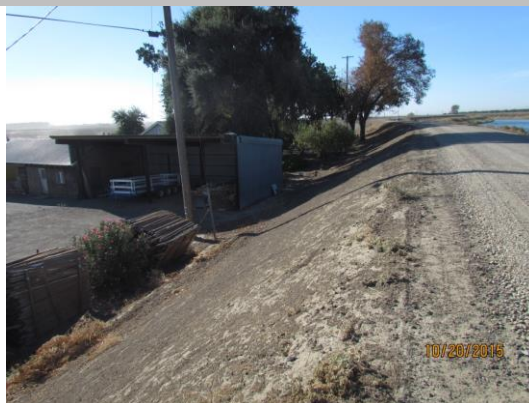
Photo 1 of 1 : SP_2018_RD1500_189_42_20180306_00033.jpg

LM Start	23.77	Rating **	M	Issue No.	42
LM End	23.77	Issue Type +	En	Location *	LS
Category	Earthen Levee			GPS Latitude/Longitude	
				Start	End
Item	Encroachments			38.931838 °	38.931838 °
				-121.834437 °	-121.834437 °
DWR ID	DWR_RD1500_01_s_2012_42				
Comment Code					
EQ : Equipment					
Inspector Comment					
Some equipment at landside toe.

View of the barn and equipment on the landward side of the levee looking downstream. Fall 2015.

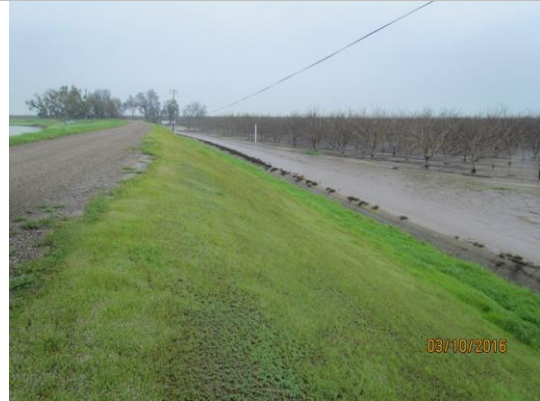
Photo 1 of 1 : SP_2018_RD1500_189_979_20180306_00085.jpg

LM Start	24.17	Rating **	M	Issue No.	979
LM End	24.31	Issue Type +	En	Location *	LS
Category	Earthen Levee			GPS Latitude/Longitude	
				Start	End
Item	Encroachments			38.936419 °	38.938426 °
				-121.830220 °	-121.829365 °
DWR ID	DWR_RD1500_01_s_2012_979				
Comment Code					
DT : Ditch					
Inspector Comment					
Concrete lined ditch located at the levee toe on the landward side of the levee.

View of the ditch on the landward side of the levee looking upstream.
Spring 2016.

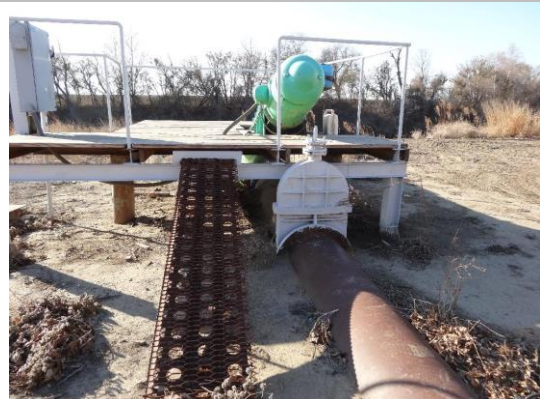
Photo 1 of 3 : UCIP_SP_2018_28603_52667.jpg

Comment Code					
Inspector Comment					
FS_ID:28603 DS_ID:24757 EP_NO: 10057 Repair Type: Non-Urgent Crossing Status: Found UCIP Comments: Plant was working during field visit. Leaky pipe near pump. FIELD_STRUCT_DESC: 24-inch steel irrigation discharge pipe through the levee, 6.5 feet below the crown. Corrugated metal cutoff wall. 1.5-inch conduit through the levee, 4 feet below the crown. Wooden walkway to a slant pump in a corrugated metal pump house on the berm. Gate valve on the berm. Hersey-Sparling meter on pipe at the waterside (WS) toe. Siphon breaker in a 24-inch corrugated metal pipe (CMP) riser on the landside (LS) shoulder. Pipe discharges into a 4-foot by 7-foot, inside dimensions, concrete distribution box at the LS toe. Meter pole at the LS toe. Field visit on 01/14/2014. (24-inch steel irrigation discharge pipe through the levee, slant pump, and all other appurtenances retained under Automatic Board Order (ABO) issued as Permit No. 10057, 1974 - David S. Lewis, care of Broomieside Farms). [Additional Reference(s): DWR Levee Log, 1990. USACE Sacramento O&M Manual 128, March 1960, (HLM 24.60)]. FS Date: 1/14/2014

WS view: slant pump on steel platform at levee berm. Walkway, exposed pipe, and gate valve on the berm.

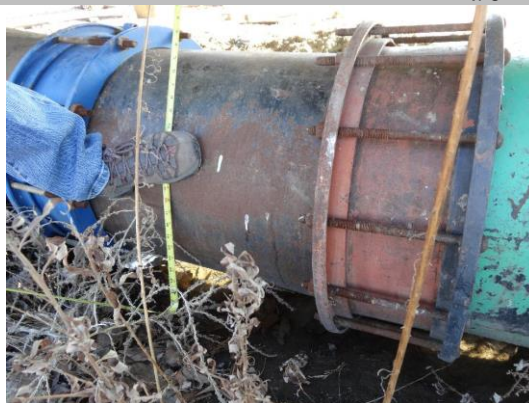
Photo 2 of 3 : UCIP_SP_2018_28603_52666.jpg

WS view: leaky pipe near pump platform. Pipe leaks from the joint.

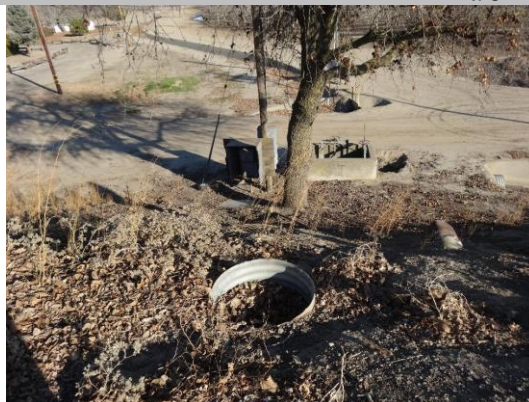
Photo 3 of 3 : UCIP_SP_2018_28603_52665.jpg

LS view: siphon breaker in CMP riser on levee slope (bottom) and concrete distribution box (top) on levee toe.

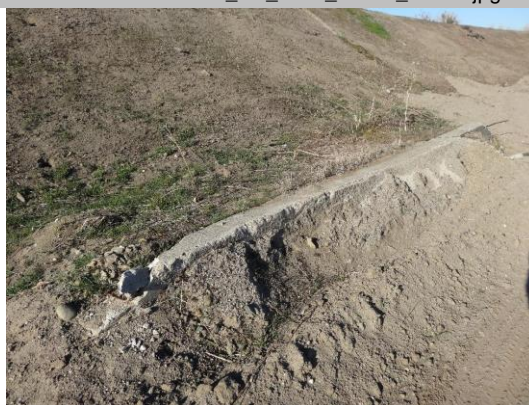
Photo 2 of 2 : UCIP_SP_2018_41728_52672.jpg

FS_ID:41728
DS_ID:20074
EP_NO: 8765
Repair Type: Non-Urgent
Crossing Status: Found
UCIP Comments: Buried Concrete headwall on landside toe. Should verify pipe has been properly abandoned. Utility tag plate on waterside shoulder. No pipe found.
FIELD_STRUCT_DESC: *ABANDONED* 48-inch by 48-inch reinforced concrete box irrigation discharge culvert through the levee, 10 feet below the crown. (48-inch by 48-inch concrete culvert retained under Permit No. 9175, 1973 - David S. Lewis, DBA Broomieside Farms. To sleeve a 20-inch steel irrigation discharge pipe through the existing concrete culvert from a new slant-type pumping facility authorized under Permit No. 8765, 1973 - David S. Lewis, DBA Broomieside Farms. The 20-inch discharge pipe will be enclosed in a 30-inch, 0.375-inch wall steel pipe.). [Additional Reference(s): DWR Levee Log, 2005. USACE Sacramento O&M Manual 128, March 1960, (HLM 25.80)].

LS view: concrete headwall on landside toe. No pipe found.

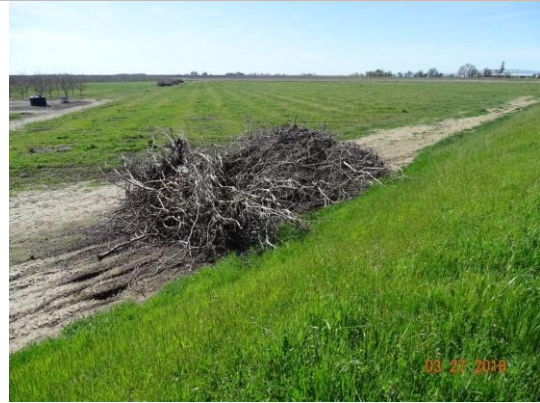
Photo 1 of 1 : SP_2018_RD1500_189_104_20180329_00234.jpg

LM Start	26.04	Rating **	M	Issue No.	104
LM End	26.04	Issue Type +	En	Location *	LS
Category	Earthen Levee			GPS Latitude/Longitude	
				Start	End
Item	Encroachments			38.958871 °	38.958871 °
				-121.832465 °	-121.832465 °
DWR ID	DWR_RD1500_01_s_2018_104				
Comment Code					
PR : Prunings					
Inspector Comment

View of pruning pile on the landside toe. Spring 2018.

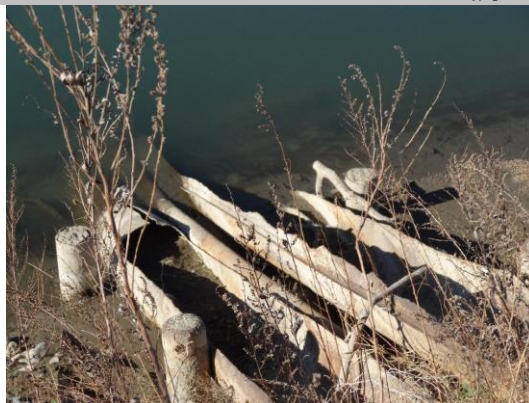
Photo 1 of 2 : UCIP_SP_2018_28628_52705.jpg

Comment Code					
Inspector Comment					
FS_ID:28628 DS_ID:20013 EP_NO: 10057 Repair Type: Non-Urgent Crossing Status: Found UCIP Comments: May need proper abandonment. FIELD_STRUCT_DESC: *ABANDONED* 2 of 2: 30-inch steel irrigation discharge pipe through the levee, 7.1 feet below the crown. Two corrugated metal cutoff walls. Siphon breakers in 24-inch and 30-inch corrugated metal pipe (CMP) risers on the landside (LS) shoulder. 2-inch conduit through the levee. Installed by USACE in 1958. Wooden walkway to two slant pumps on a steel pile structure on berm. Meter pole and switch panel at the LS toe. (Steel discharge pipes, slant pumps, and all other appurtenances retained under Automatic Board Order (ABO) issued as Permit No. 10057, 1974 - David S. Lewis, care of Broomieside Farms, [RM 112.06]. Moved to HLM 26.50 under Permit No. 16165, 1994 - Pelger Mutual Water Company/Murray, Burns, and Kienlen). [Additional Reference(s): DWR Levee Log, 1993. USACE Sacramento O&M Manual 128, March 1960, (HLM 26.84)]. FS Date: 1/15/2014

WS view: abandoned 24" and 30" steel pipe on river bank.

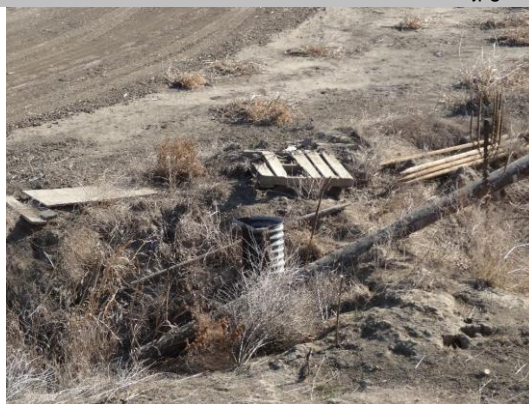
Photo 2 of 2 : UCIP_SP_2018_28628_52704.jpg

LS view: abandoned CMP risers on levee toe.

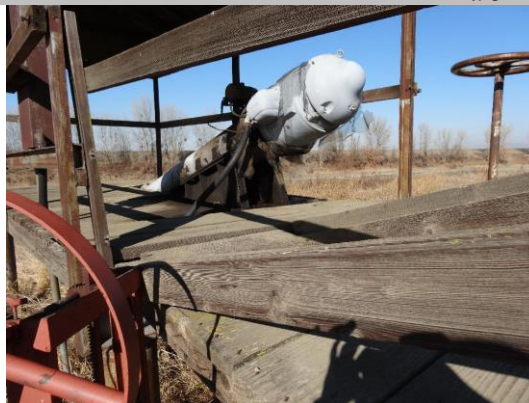
Photo 1 of 3 : UCIP_SP_2018_28631_52720.jpg

Comment Code					
Inspector Comment					
FS_ID:28631 DS_ID:20015 EP_NO: 10052 Repair Type: Non-Urgent Crossing Status: Found UCIP Comments: Obstructed siphon breaker. Leaky pump. FIELD_STRUCT_DESC: 18-inch steel irrigation discharge pipe through the levee, 7.1 feet below the crown. Corrugated metal cutoff wall. 2-inch conduit through the levee, 5.5 feet below the crown. Wooden walkway to slant pump and gate valve on wooden pump platform mounted on a steel pile structure on the berm. Siphon breaker in a 24-inch corrugated metal pipe (CMP) riser on the landside (LS) slope. Meter pole at the LS toe. (18-inch steel irrigation discharge pipe through the levee, slant pump, and all other appurtenances retained under Automatic Board Order (ABO) issued as Permit No. 10052, 1974 - Clifton Lamb, [RM 112.29]). [Additional Reference(s): DWR Levee Log, 1993. USACE Sacramento O&M Manual 128, March 1960, (HLM 27.07)]. FS Date: 1/15/2014

WS view: slant pump and gate valves on wooden platform at levee berm. Wooden walkway to the pump.

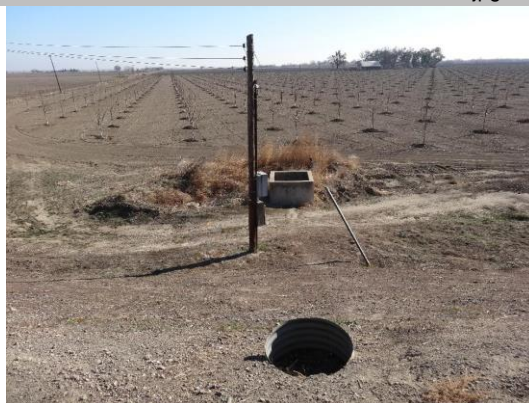
Photo 2 of 3 : UCIP_SP_2018_28631_52719.jpg

LS view: siphon breaker in CMP riser on levee slope (bottom) and concrete distribution box on levee toe.

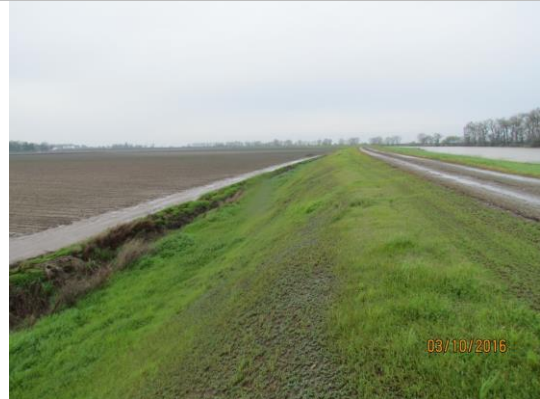
Photo 1 of 1 : SP_2018_RD1500_189_983_20180306_00086.jpg

LM Start	27.31	Rating **	M	Issue No.	983
LM End	27.44	Issue Type +	En	Location *	LS
Category	Earthen Levee			GPS Latitude/Longitude	
				Start	End
Item	Encroachments			38.972552 °	38.972924 °
				-121.825574 °	-121.823198 °
DWR ID	DWR_RD1500_01_s_2015_983				
Comment Code					
DT : Ditch					
Inspector Comment

View of the ditch on the landward side of the levee looking downstream.
Spring 2016.

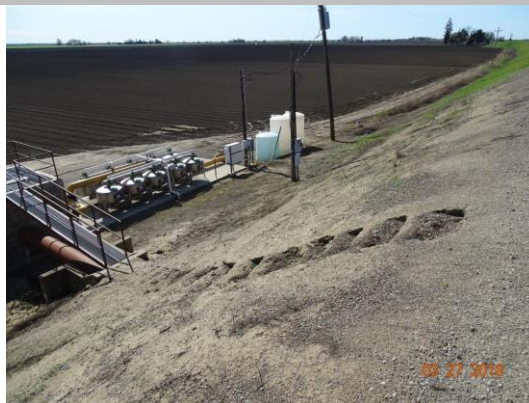
Photo 1 of 1 : SP_2018_RD1500_189_96_20180329_00233.jpg

LM Start	28.16	Rating **	M	Issue No.	96
LM End	28.16	Issue Type +	En	Location *	LS
Category	Earthen Levee			GPS Latitude/Longitude	
				Start	End
Item	Encroachments			38.982180 °	38.982180 °
				-121.819979 °	-121.819979 °
DWR ID	DWR_RD1500_01_s_2018_96				
Comment Code					
ST : Stairway					
Inspector Comment					
Steps dug out on the landside levee slope.

View of steps on the landside slope. Spring 2018.

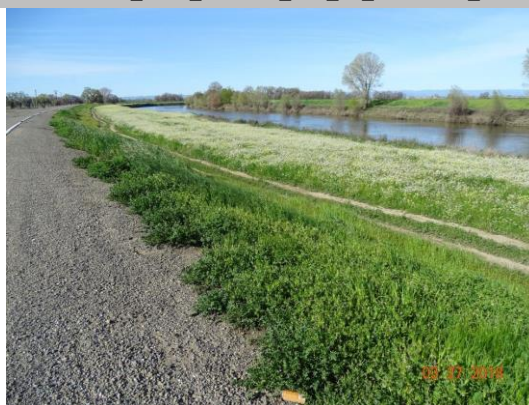
Photo 1 of 1 : SP_2018_RD1500_189_95_20180329_00232.jpg

LM Start	28.18	Rating **	M	Issue No.	95
LM End	31.53	Issue Type +	Ma	Location *	WS
Category	Earthen Levee			GPS Latitude/Longitude	
				Start	End
Item	Vegetation			38.982460 °	39.006748 °
				-121.819955 °	-121.814709 °
DWR ID	DWR_RD1500_01_s_2018_95				
Comment Code					
V1 : Control annual grass and weeds on the levee slopes and easements.					
Inspector Comment

View of vegetation on the waterside slope. Spring 2018

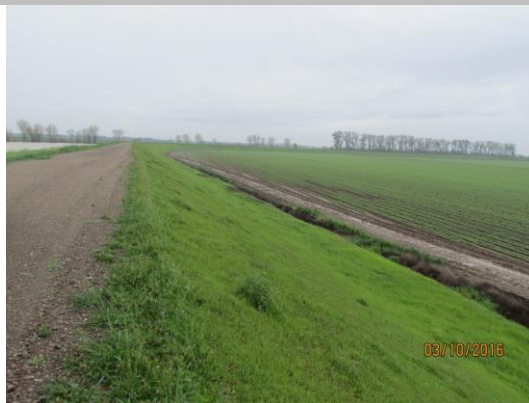
Photo 1 of 1 : SP_2018_RD1500_189_38_20180306_00032.jpg

LM Start	28.23	Rating **	M	Issue No.	38
LM End	29.23	Issue Type +	En	Location *	LS
Category	Earthen Levee			GPS Latitude/Longitude	
				Start	End
Item	Encroachments			38.983119 °	38.988538 °
				-121.819923 °	-121.806445 °
DWR ID	DWR_RD1500_01_s_2012_38				
Comment Code					
DT : Ditch					
Inspector Comment

View of the ditch on the landward side of the levee looking upstream.
Spring 2016.

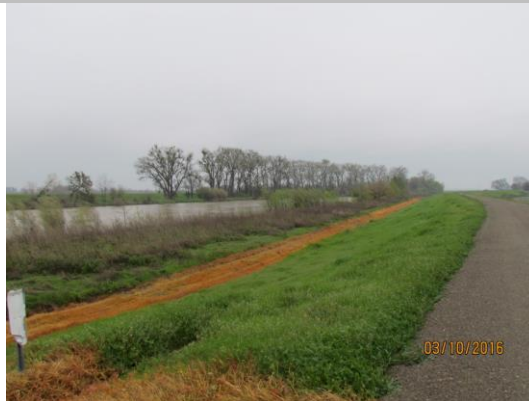
Photo 1 of 2 : SP_2018_RD1500_189_84_20180306_00043.jpg

LM Start	28.94	Rating **	A/W	Issue No.	84
LM End	29.17	Issue Type +	Ob	Location *	WS
Category	Earthen Levee			GPS Latitude/Longitude	
				Start	End
Item	Vegetation			38.988072 °	38.988572 °
				-121.811737 °	-121.807520 °
DWR ID	DWR_RD1500_01_s_2012_84				
Comment Code					
V8 : Environmental Requirements.					
Inspector Comment

View of the revegetation site on the waterward side of the levee looking upstream. Spring 2016.

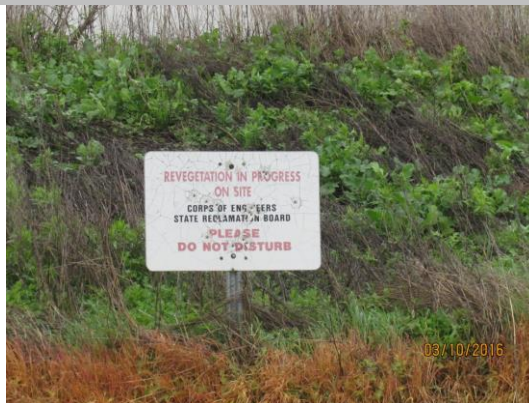
Photo 2 of 2 : SP_2018_RD1500_189_84_20180306_00044.jpg

Sign for the revegetation site. Spring 2016.

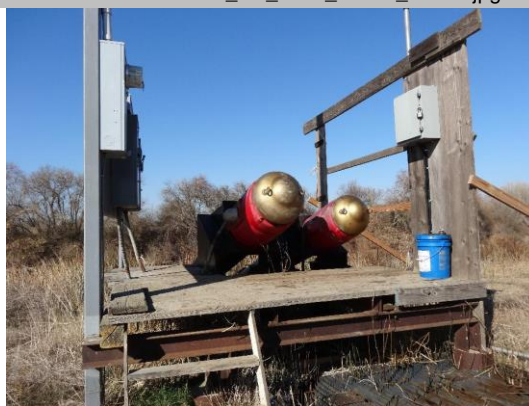
Photo 1 of 3 : UCIP_SP_2018_50194_51834.jpg

Comment Code					
Inspector Comment					
FS_ID:50194 DS_ID:20113 EP_NO: 10054 Repair Type: Non-Urgent Crossing Status: Found UCIP Comments: 08/29/2016: Found no evidence of leakage or subsidence. CMP risers are both silted in and need lids. Need a name change permit for new owner Brad Howalt. Possible sink hole in alignment with pipes on crown has been covered with concrete. Crossing has been downgraded from Urgent to Non-Urgent. (K. Fazel - UCIP)01/15/2014:Levee slope erosion due to leakage from siphon breaker.Water leaking from pipe near distribution box on landside levee toe.Overhead powerline. (P. Amatya - DWR) FIELD_STRUCT_DESC: 2 of 2: 16-inch steel irrigation discharge pipe through the levee, 5 feet below the crown. Corrugated metal cutoff wall. Two siphon breakers in two 24-inch corrugated metal pipe (CMP) risers on the landside (LS) shoulder. Installed by USACE in 1952. Two slant pumps in a corrugated metal pump house mounted on a steel pile structure on the berm. 4-foot by 7-foot concrete inspection box for a Hersey-Sparling water meter on the berm in front of the pump house. Two flap gates in a 9.7-foot by 10.6-foot, outside dimensions, concrete distribution box at the LS toe. (16-inch steel irrigation discharge pipe through the levee, slant pumps, and all other appurtenances retained under Automatic Board Order (ABO) issued as Permit No. 10054, 1974 - William A. Larner). [Additional Reference(s): DWR Levee Log, 1993. USACE Sacramento O&M Manual 128, March 1960, (HLM 30.29), 14-inch pipe referenced]. FS Date: 8/29/2016

WS view: two slant pumps on wooden platform on levee berm.

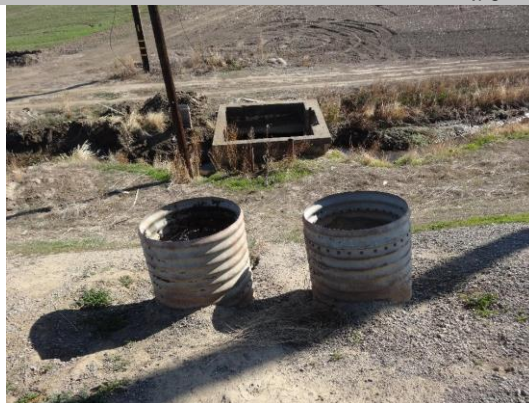
Photo 3 of 3 : UCIP_SP_2018_50194_52880.jpg

Comment Code					
Inspector Comment					
FS_ID:50194 DS_ID:20113 EP_NO: 10054 Repair Type: Non-Urgent Crossing Status: Found UCIP Comments: 08/29/2016: Found no evidence of leakage or subsidence. CMP risers are both silted in and need lids. Need a name change permit for new owner Brad Howalt. Possible sink hole in alignment with pipes on crown has been covered with concrete. Crossing has been downgraded from Urgent to Non-Urgent. (K. Fazel - UCIP)01/15/2014:Levee slope erosion due to leakage from siphon breaker.Water leaking from pipe near distribution box on landside levee toe.Overhead powerline. (P. Amatya - DWR) FIELD_STRUCT_DESC: 2 of 2: 16-inch steel irrigation discharge pipe through the levee, 5 feet below the crown. Corrugated metal cutoff wall. Two siphon breakers in two 24-inch corrugated metal pipe (CMP) risers on the landside (LS) shoulder. Installed by USACE in 1952. Two slant pumps in a corrugated metal pump house mounted on a steel pile structure on the berm. 4-foot by 7-foot concrete inspection box for a Hersey-Sparling water meter on the berm in front of the pump house. Two flap gates in a 9.7-foot by 10.6-foot, outside dimensions, concrete distribution box at the LS toe. (16-inch steel irrigation discharge pipe through the levee, slant pumps, and all other appurtenances retained under Automatic Board Order (ABO) issued as Permit No. 10054, 1974 - William A. Larner). [Additional Reference(s): DWR Levee Log, 1993. USACE Sacramento O&M Manual 128, March 1960, (HLM 30.29), 14-inch pipe referenced]. FS Date: 8/29/2016

LS view: siphon breakers in CMP riser on levee slope and distribution box on levee toe.

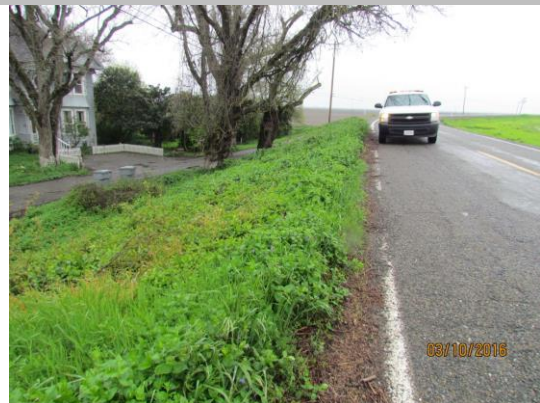
Photo 1 of 1 : SP_2018_RD1500_189_45_20180306_00034.jpg

LM Start	30.22	Rating **	M	Issue No.	45
LM End	30.22	Issue Type +	En	Location *	LS
Category	Earthen Levee			GPS Latitude/Longitude	
				Start	End
Item	Vegetation			38.997027 °	38.997027 °
				-121.794755 °	-121.794755 °
DWR ID	DWR_RD1500_01_s_ 2012_45				
Comment Code					
V6 : Landscaping					
Inspector Comment

View of the groundcover on the landward side of the levee looking downstream. Spring 2016.

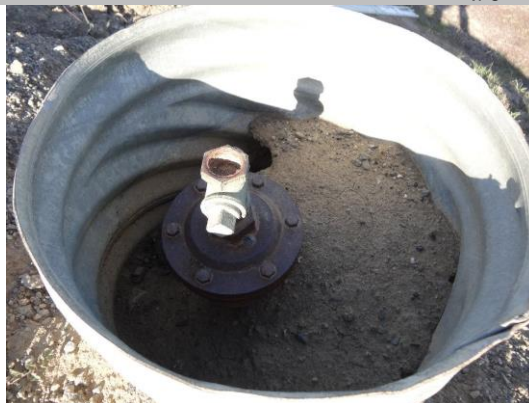
Photo 2 of 3 : UCIP_SP_2018_28144_51811.jpg

Item	DWR UCIP Field Study			39.002960 °		39.002960 °
				-121.803736 °		-121.803736 °
DWR ID						
Comment Code						
Inspector Comment						
FS_ID:28144 DS_ID:20000 EP_NO: 15916 Repair Type: Non-Urgent Crossing Status: Found UCIP Comments: Surface erosion due to leaky pressure breaker on landside slope. FIELD_STRUCT_DESC: 18-inch steel irrigation discharge pipe through the levee, at an unknown depth. Waterside (WS) pump not mentioned in the Levee Log. Siphon breaker in a 24-inch corrugated metal pipe (CMP) riser on the landside (LS) slope. Pipe discharges into a 6-foot by 8-foot, inside dimensions, concrete distribution box at the LS toe. Installed by USACE in 1951. (12-inch steel irrigation discharge pipe through the levee and all other appurtenances retained under Automatic Board Order (ABO) issued as Permit No. 10034, 1974 - Leslie A. Butler. Replacement of the existing 12-inch discharge pipe with a new 18-inch discharge pipe through the levee authorized under Permit No. 15916, 1992 - Leslie A. Butler). [Additional Reference(s): DWR Levee Log, 1993. USACE Sacramento O&M Manual 128, March 1960, (HLM 31.26)]. FS Date: 1/15/2014

LS view: obstructed and leaked pressure breaker in CMP on levee slope.

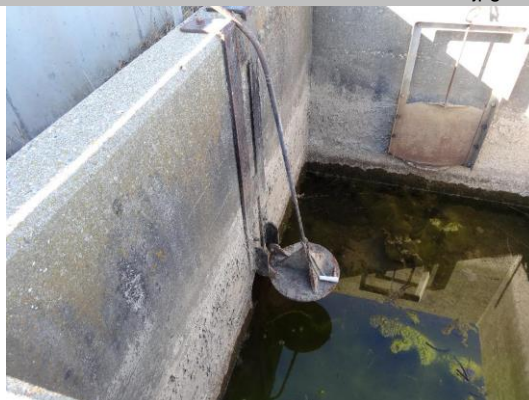
Photo 3 of 3 : UCIP_SP_2018_28144_51815.jpg

LS view: corroded flap gate in concrete distribution box.

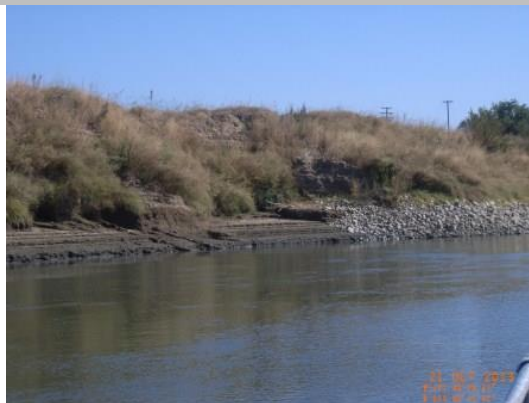
Photo 1 of 1 : SP_2018_RD1500_189_15_20180306_00014.jpg

Comment Code					
Inspector Comment					
2003 - New sedimentation and some new small toe scallops at the upstream end; downstream end has some new erosion. 2004 - Some new erosion at the toe and upper bank and some small new rotational failures (mainly minor, except at the downstream end). 2007 - Some new slumps. 2009 - Some new scallops and site was extended upstream. 2010 - New deposition along upstream end of site, however there is also new erosion throughout the site. Site seems to be worsening, and eroding fast. Large habitat for bank swallows. 2011 - Some new minor erosion. 2012 - Minor new erosion. 2015: No observed changes. [2015 Site ID: SAC_116-5_L]

USACE 2013 Photo #1

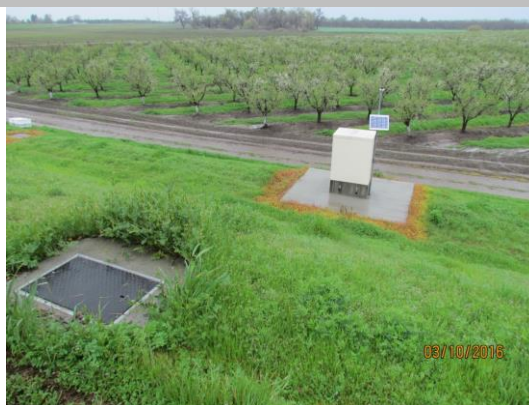
Photo 1 of 2 : SP_2018_RD1500_189_86_20180306_00045.jpg

LM Start	31.54	Rating **	A/W	Issue No.	86
LM End	31.54	Issue Type +	Ma	Location *	LS
Category	Earthen Levee			GPS Latitude/Longitude	
				Start	End
Item	Encroachments			39.006687 °	39.006687 °
				-121.814967 °	-121.814967 °
DWR ID	DWR_RD1500_01_s_2016_86				
Comment Code					
MW : Monitoring Well					
Inspector Comment					
UCIP installed this monitoring station for seepage in the area. Monitor for vandilism or damagePN: (18630).

View of the pizometer on the landward side of the levee. Spring 2016.

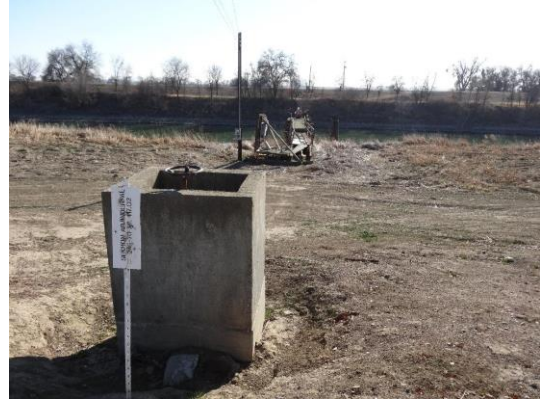
Photo 1 of 3 : UCIP_SP_2018_28143_51805.jpg

FS_ID:28143
 DS_ID:20077
 EP_NO: 9657
 Repair Type: Non-Urgent
 Crossing Status: Found
 UCIP Comments: Looks abandoned. May need proper abandonment. Overhead power line.
 FIELD_STRUCT_DESC: *ABANDONED* 20-inch steel irrigation discharge pipe through the levee, 15 feet below the crown. Wooden step and walkway to vertical pump on pile structure in the river. Slide gate in a 2.5-foot by 3-foot, inside dimensions, riser. Concrete distribution box on the waterside (WS) slope. Switch panel on the berm. Pipe discharges into a 36-inch, inside diameter, concrete standpipe on the landside (LS). Installed by USACE in 1947. (Replacement of a section of 24-inch irrigation pipe through the levee authorized under Permit No. 9657, 1974 - Clyde M. Bell. 1.5-foot by 2-foot concrete culvert through the levee and all other appurtenances retained under Automatic Board Order (ABO) issued as Permit No. 10030, 1974 - Clyde M. Bell. Replacement of a cracked concrete pipe with a steel pipe at the LS toe authorized under Permit No. 13536, 1982 - Niechen N. V., Alfred Montna, Manager. Replacement of approximately 90 feet of 18-inch pipe in the overflow area of the Sacramento River with new steel pipe authorized under Permit No. 13941, 1984 - Niechen N. V., Alfred Montna, Manager). [Additional Reference(s): DWR Levee Log, 2005. USACE Sacramento O&M Manual 128, March 1960, (HLM 32.02), 2-foot by 2-foot concrete culvert referenced].

WS view: concrete surge box on levee slope.

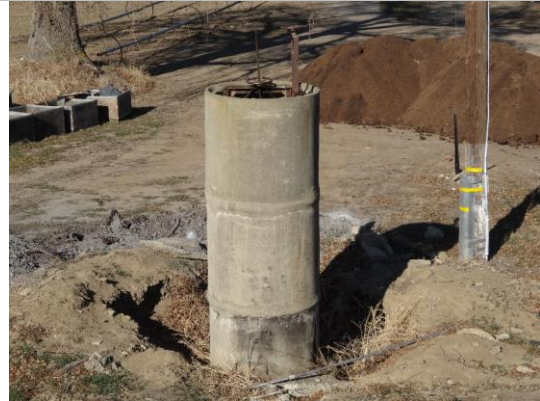
Photo 3 of 3 : UCIP_SP_2018_28143_51803.jpg

Item	DWR UCIP Field Study			39.006484 °	39.006484 °	
				-121.816168 °	-121.816168 °	
DWR ID						
Comment Code						
Inspector Comment						
FS_ID:28143 DS_ID:20077 EP_NO: 9657 Repair Type: Non-Urgent Crossing Status: Found UCIP Comments: Looks abandoned. May need proper abandonment.Overhead power line. FIELD_STRUCT_DESC: *ABANDONED* 20-inch steel irrigation discharge pipe through the levee, 15 feet below the crown. Wooden step and walkway to vertical pump on pile structure in the river. Slide gate in a 2.5-foot by 3-foot, inside dimensions, riser. Concrete distribution box on the waterside (WS) slope. Switch panel on the berm. Pipe discharges into a 36-inch, inside diameter, concrete standpipe on the landside (LS). Installed by USACE in 1947. (Replacement of a section of 24-inch irrigation pipe through the levee authorized under Permit No. 9657, 1974 - Clyde M. Bell. 1.5-foot by 2-foot concrete culvert through the levee and all other appurtenances retained under Automatic Board Order (ABO) issued as Permit No. 10030, 1974 - Clyde M. Bell. Replacement of a cracked concrete pipe with a steel pipe at the LS toe authorized under Permit No. 13536, 1982 - Niechen N. V., Alfred Montna, Manager. Replacement of approximately 90 feet of 18-inch pipe in the overflow area of the Sacramento River with new steel pipe authorized under Permit No. 13941, 1984 - Niechen N. V., Alfred Montna, Manager). [Additional Reference(s): DWR Levee Log, 2005. USACE Sacramento O&M Manual 128, March 1960, (HLM 32.02), 2-foot by 2-foot concrete culvert referenced]. FS Date: 1/15/2014

LS view: concrete standpipe on levee toe.

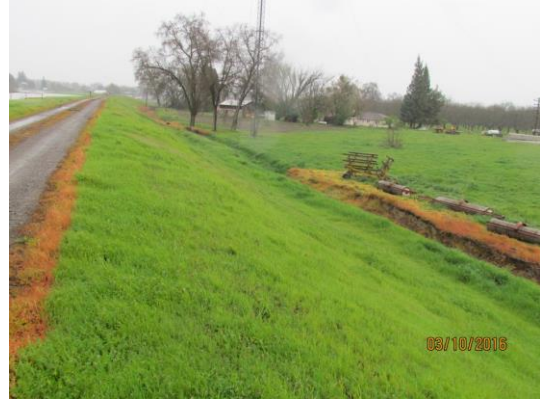
Photo 1 of 1 : SP_2018_RD1500_189_60_20180306_00038.jpg

LM Start	32.42	Rating **	M	Issue No.	60
LM End	32.57	Issue Type +	En	Location *	LS
Category	Earthen Levee			GPS Latitude/Longitude	
				Start	End
Item	Encroachments			39.013749 °	39.015620 °
				-121.825065 °	-121.823461 °
DWR ID	DWR_RD1500_01_s_2012_60				
Comment Code					
DT : Ditch					
Inspector Comment					
Ditch is located at the toe of the levee.

View of the ditch on the landward side of the levee looking upstream.
Spring 2016.

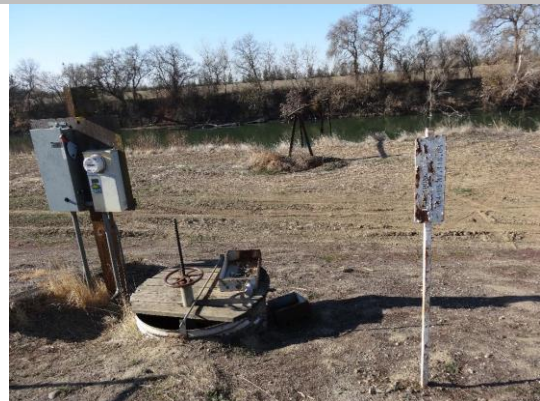
Photo 1 of 3 : UCIP_SP_2018_28943_53222.jpg

Comment Code					
Inspector Comment					
FS_ID:28943 DS_ID:20018 EP_NO: N/A Repair Type: Non-Urgent Crossing Status: Found UCIP Comments: Pipe leaks near pump through a hole in the pipe. Needs repair. An electric conduit through the levee. Concrete distribution box on landside levee toe. Slide gate in CMP on waterside slope. FIELD_STRUCT_DESC: 30-inch reinforced concrete encased steel irrigation discharge pipe through the levee, 16 feet below the crown. 2-inch steel conduit through the levee. Two reinforced concrete cutoff walls. Vertical pump on a structure in the river. Slide gate in a 48-inch corrugated metal pipe (CMP) riser on the waterside (WS) slope. Power pole and switch panel on the WS slope. Pipe discharges into a 5-foot by 5-foot concrete distribution box in an irrigation ditch at the landside (LS) toe. Power pole at the LS toe. Installed by USACE in 1964. (30-inch reinforced concrete encased steel irrigation discharge pipe through the levee, vertical pump, and all other appurtenances retained under Automatic Board Order (ABO) issued as Permit No. 10079, 1974 - Russell L. Young). [Additional Reference(s): DWR Levee Log, 1993. USACE Sacramento O&M Manual 128, March 1960, (HLM 32.97)]. FS Date: 1/15/2014

WS view: power control panel and CMP riser with slide gate on levee slope.

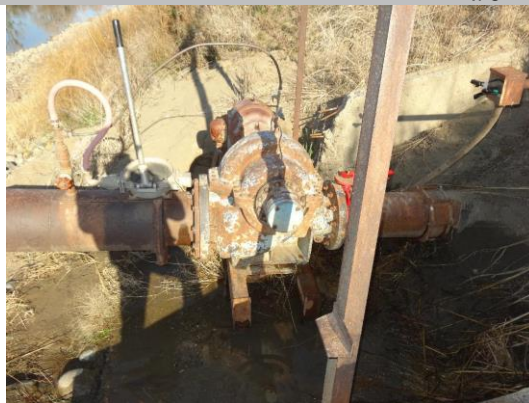
Photo 2 of 3 : UCIP_SP_2018_28943_53221.jpg

Item	DWR UCIP Field Study			39.015277 °	39.015277 °	
				-121.823735 °	-121.823735 °	
DWR ID						
Comment Code						
Inspector Comment						
FS_ID:28943 DS_ID:20018 EP_NO: N/A Repair Type: Non-Urgent Crossing Status: Found UCIP Comments: Pipe leaks near pump through a hole in the pipe. Needs repair.An electric conduit through the levee. Concrete distribution box on landside levee toe. Slide gate in CMP on waterside slope. FIELD_STRUCT_DESC: 30-inch reinforced concrete encased steel irrigation discharge pipe through the levee, 16 feet below the crown. 2-inch steel conduit through the levee. Two reinforced concrete cutoff walls. Vertical pump on a structure in the river. Slide gate in a 48-inch corrugated metal pipe (CMP) riser on the waterside (WS) slope. Power pole and switch panel on the WS slope. Pipe discharges into a 5-foot by 5-foot concrete distribution box in an irrigation ditch at the landside (LS) toe. Power pole at the LS toe. Installed by USACE in 1964. (30-inch reinforced concrete encased steel irrigation discharge pipe through the levee, vertical pump, and all other appurtenances retained under Automatic Board Order (ABO) issued as Permit No. 10079, 1974 - Russell L. Young). [Additional Reference(s): DWR Levee Log, 1993. USACE Sacramento O&M Manual 128, March 1960, (HLM 32.97)]. FS Date: 1/15/2014

WS view: pump on river bank protected by concrete headwall. Leaky pipe near pump.

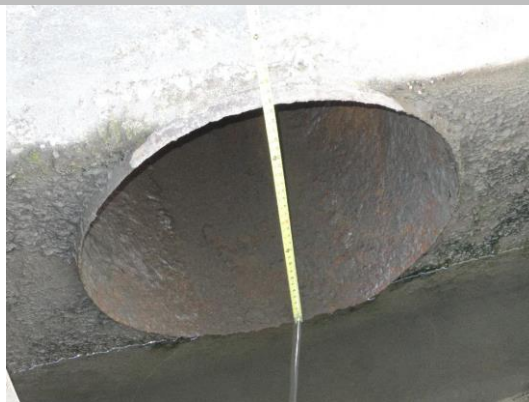
Photo 3 of 3 : UCIP_SP_2018_28943_53220.jpg

LS view: steel pipe in concrete distribution box on levee toe.

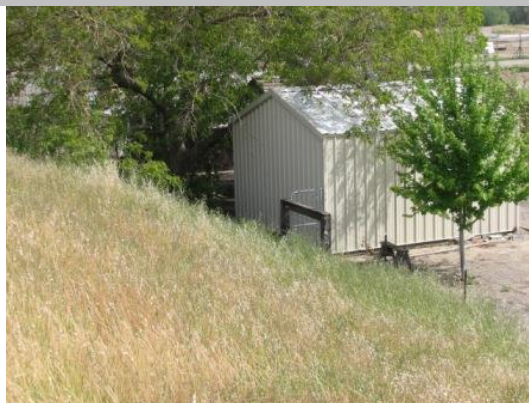
Photo 1 of 1 : SP_2018_RD1500_189_46_20180306_00035.jpg

LM Start	32.96	Rating **	M	Issue No.	46
LM End	32.96	Issue Type +	En	Location *	LS
Category	Earthen Levee			GPS Latitude/Longitude	
				Start	End
Item	Encroachments			39.020550 °	39.020550 °
				-121.820315 °	-121.820315 °
DWR ID	DWR_RD1500_01_s_2012_46				
Comment Code					
BU : Building					
Inspector Comment

The building is within the easement of the levee toe.

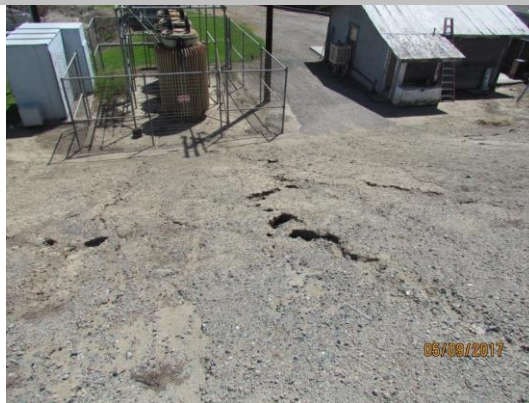
Photo 1 of 1 : SP_2018_RD1500_189_144_20180306_00075.jpg

LM Start	32.98	Rating **	M	Issue No.	144
LM End	32.98	Issue Type +	Ma	Location *	LS
Category	Earthen Levee			GPS Latitude/Longitude	
				Start	End
Item	Erosion / Bank Caving			39.020782 °	39.020782 °
				-121.820275 °	-121.820275 °
DWR ID	DWR_RD1500_01_s_2017_144				
Comment Code					
E2 : Schedule repair of erosion site prior to the next inspection.					
Inspector Comment					
Runoff erosion on landside slope.

View of erosion on landside slope. Spring 2017.

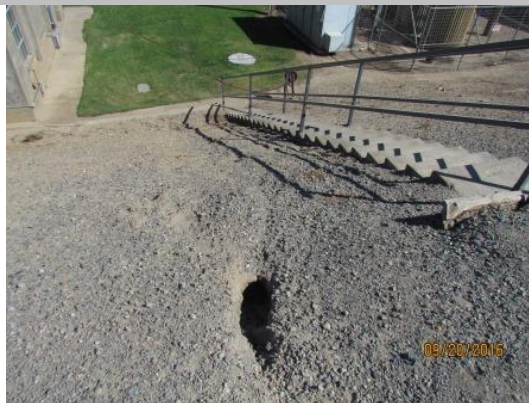
Photo 1 of 1 : SP_2018_RD1500_189_107_20180306_00054.jpg

LM Start	32.98	Rating **	M	Issue No.	107
LM End	32.98	Issue Type +	Ma	Location *	LS
Category	Earthen Levee			GPS Latitude/Longitude	
				Start	End
Item	Animal Control			39.020874 °	39.020874 °
				-121.820266 °	-121.820266 °
DWR ID	DWR_RD1500_01_f_2016_107				
Comment Code					
A3 : No rodents visible, but rodent burrows visible; need to backfill and compact or grout burrows.					
Inspector Comment

View of rodent burrows on landside slope. Fall 2016.
